Re: Construction Safety Survey
Omaha, NE

Construction Report

Completed for: Best Company
Report Name: Construction
Location: Omaha, NE
Contact: Bob Jones, Superintendent
Project #: 12355

Inspection Date: October 02, 2016

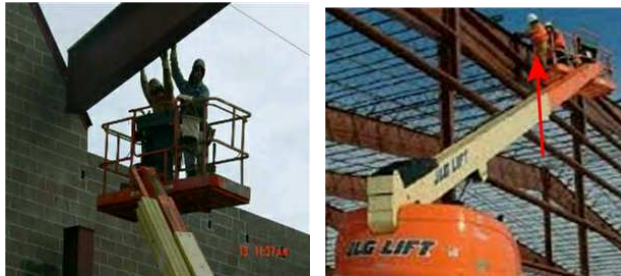
Observation Worker(s) observed standing on toeboard or rail of lift, did not keep both feet on floor of basket (1926.453)

Notes: Worker observed with one foot on mid rail

Workers have both feet on floor of lift

Recommendation When working from an aerial lift, employees must stand firmly on the floor of the basket and not be allowed to step or climb on toebard or railing of basket or use planks, ladders or other devices for a work position [reference 1926.453(b)(2)(iv)]. [View OSHA Standard](#)

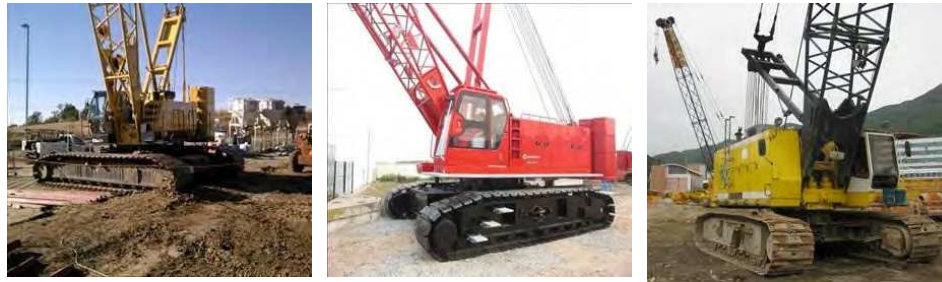
Observation Accessible areas within swing radius of crane are not barricaded to prevent workers from being struck or crushed (1926.1424)

Notes: Radius guard is installed but not flagged per policy.

Severity Rating: Advisory

Radius guard not installed.

Recommendation Make sure all accessible areas within swing radius of crane are barricaded to prevent workers from being struck or crushed [reference 1926.1424(a)]. [View OSHA Standard](#)
