Re: Construction Safety Survey
Omaha, NE

Construction Report

Completed for: Best Company
Report Name: Construction
Location: Omaha, NE
Contact: Bob Jones, Superintendent
Project #: 12355

Inspection Date: October 02, 2016

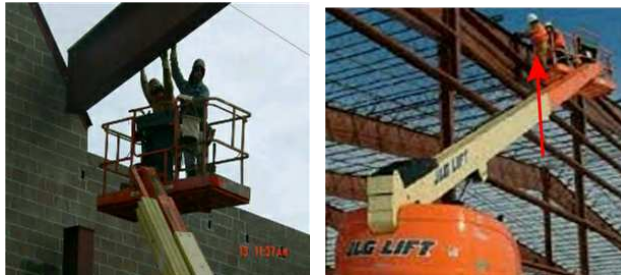
Observation **Worker(s) observed standing on toeboard or rail of lift, did not keep both feet on floor of basket (1926.453)**

Notes: Worker observed with one foot on mid rail

Workers have both feet on floor of lift

Recommendation *When working from an aerial lift, employees must stand firmly on the floor of the basket and not be allowed to step or climb on toeboard or railing of basket or use planks, ladders or other devices for a work position [reference 1926.453(b)(2)(iv)]. [View OSHA Standard](#)*

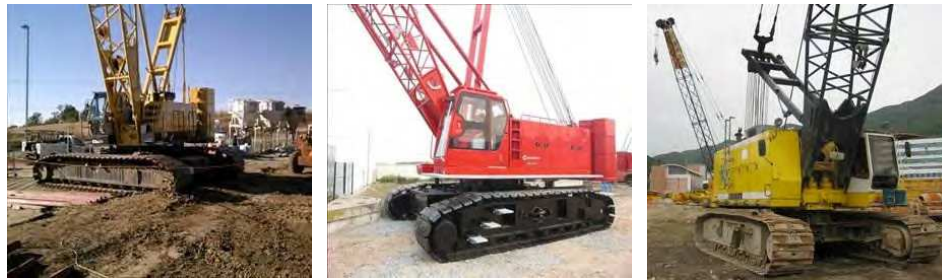
Notes: Radius guard is installed but not flagged per policy.

Severity Rating: Advisory

Radius guard not installed.

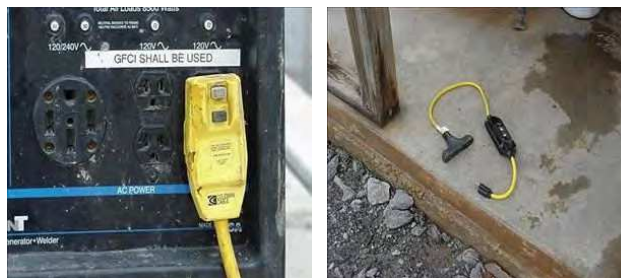
Observation GFCI is used for temporary power connections (1926.404)

Notes: Good use of GFCI

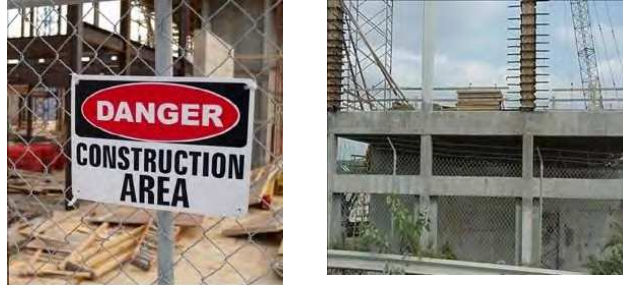
Observation Measures are taken (i.e. fencing, signs, etc.) to restrict public access to jobsite (ANSI A10.34-2001 (R2012) Section 3.2.9)

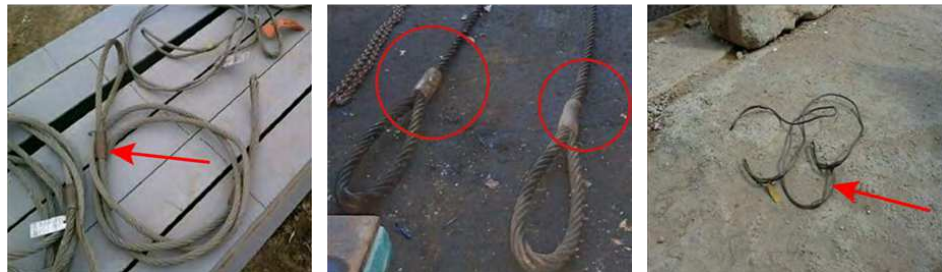
Observation **Not all rigging equipment is properly tagged/labeled with required markings (1926.251)**

Specification tag missing

Spec tags missing

Recommendation *Employers must ensure that all rigging equipment (i.e. slings, fastenings, attachments, etc.) has permanently affixed and legible identification markings as prescribed by the manufacturer that indicate the recommended safe working load. Rigging equipment shall not be used if markings are missing or illegible. [reference 1926.251(a)(2)(i) and (iii)]*
[View OSHA Standard](#)
