SAFETY REPORTS

Re: Construction Safety Survey
Omaha, NE

Construction Report

Inspection Date: October 02, 2016
 Completed for: Best Company
 Report Name: Construction
 Location: Omaha, NE
 Contact: Bob Jones, Superintendent
 Project #: 12355
 Score: 70%
 Scope of Work: Safety Inspection

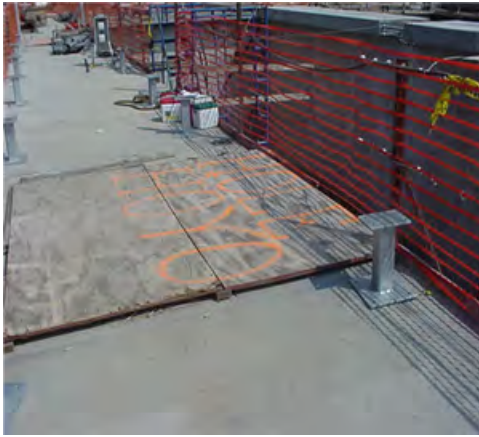
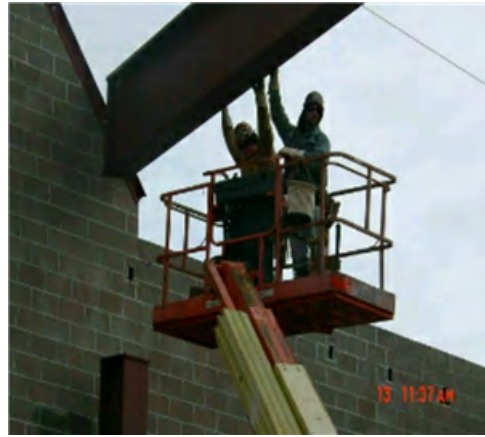
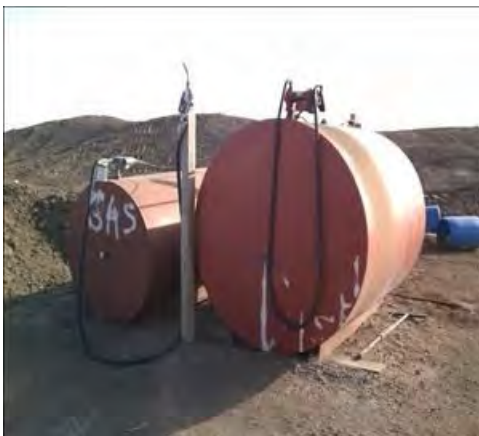
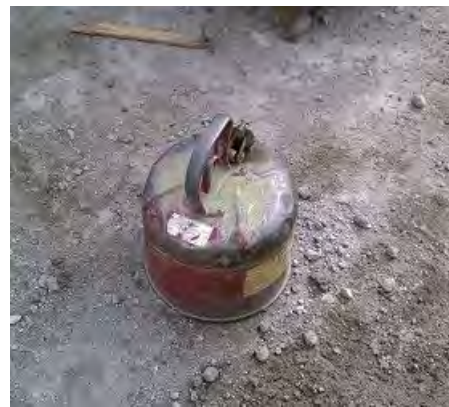
#	Category	Observations:
1	Aerial/Boom Lifts	Worker(s) observed standing on toeboard or rail of lift, did not keep both feet on floor of basket (1926.453) (See Photo) <i>Note: Worker observed with one foot on mid rail</i>
6	Cranes	Accessible areas within swing radius of crane are not barricaded to prevent workers from being struck or crushed (1926.1424) (See Photo) <i>Note: Radius guard is installed but not flagged per policy.</i>
8	Electrical Safety	Extension cord(s) in poor condition, i.e. worn or frayed (1926.416) (See Photo) <i>Note: Most cords were in good condition. This is the only cord found with damage.</i>
8	Electrical Safety	Cords not protected/kept clear of working spaces and walkways (1926.416) (See Photo) <i>Note: Remove cord or suspend it to keep out of water and pedestrian traffic.</i>
10	Fall Protection	The PFA System does not protect employee(s) from coming in contact with lower level

Workers have both feet on floor of lift

- *When working from an aerial lift, employees must stand firmly on the floor of the basket and not be allowed to step or climb on toeboard or railing of basket or use planks, ladders or other devices for a work position [reference 1926.453(b)(2)(iv)]. [View OSHA Standard](#)*
 - Note: Worker observed with one foot on mid rail
 - Responsible Party: E.J. Erectors

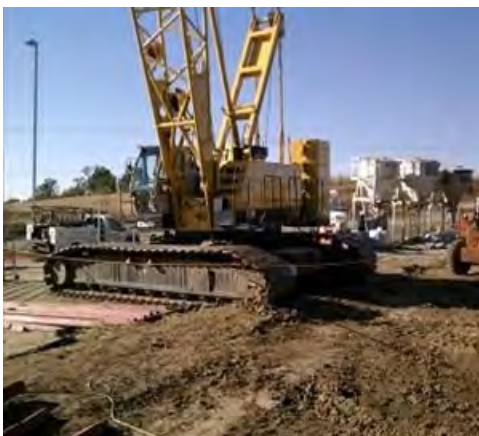
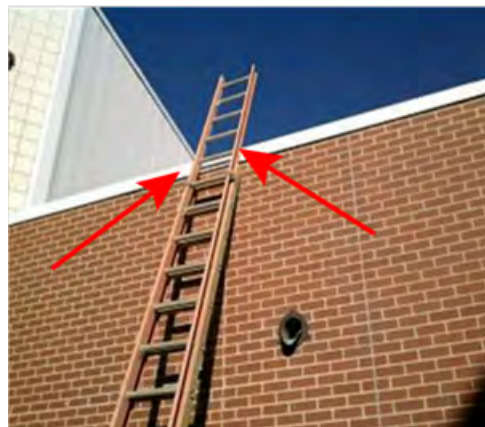
Ladder not secured to prevent side slip

- *Ladders must be set up at proper angle where the horizontal distance from the top support to the foot of ladder is approximately 1/4 of the working length of the ladder [reference 1926.1053(b)(5)(I)]. [View OSHA Standard](#)*
 - Note: Ladder is sagging, needs to be placed at proper angle.
 - Responsible Party: E.J. Erectors
- *Take appropriate steps to secure ladder side rails to a rigid support to prevent the ladder from slipping sideways [reference 1926.1053(b)(1)] [View OSHA Standard](#)*
 - Note: Need to schedule meeting with subs to remind everyone that ladders need to be tied off.

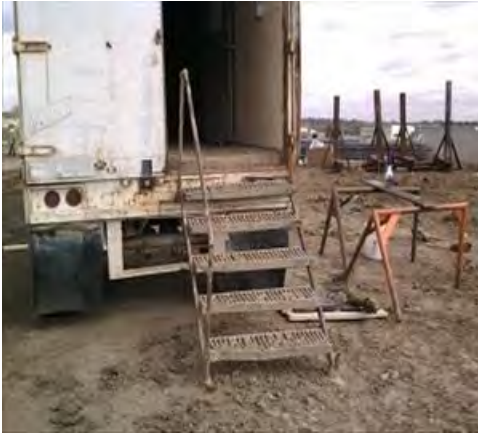
Need handrail on steps to storage trailer

- Responsible Party: Best Contractor, E.J. Erectors
- *Stairways having four or more risers or rising more than 30 inches, whichever is less, shall be equipped with at least one handrail or two if both sides are open [reference 1926.1052(c)]. Provide handrails as required. [View OSHA Standard](#)*
 - Responsible Party: Columbia Plumbing

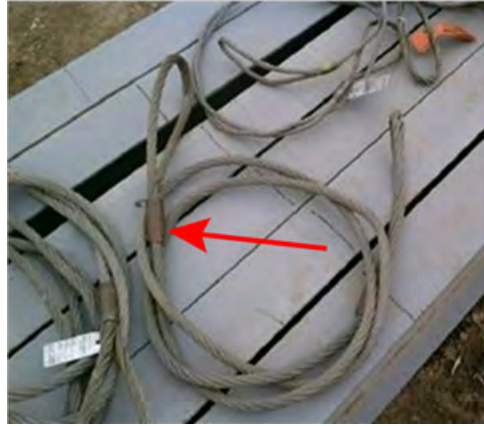
Side rails not secured

Specification tag missing

- *Employers must ensure that all rigging equipment (i.e. slings, fastenings, attachments, etc.) has permanently affixed and legible identification markings as prescribed by the manufacturer that indicate the recommended safe working load. Rigging equipment shall not be used if markings are missing or illegible. [reference 1926.251(a)(2)(i) and (iii)] [View OSHA Standard](#)*
 - Responsible Party: Best Contractor

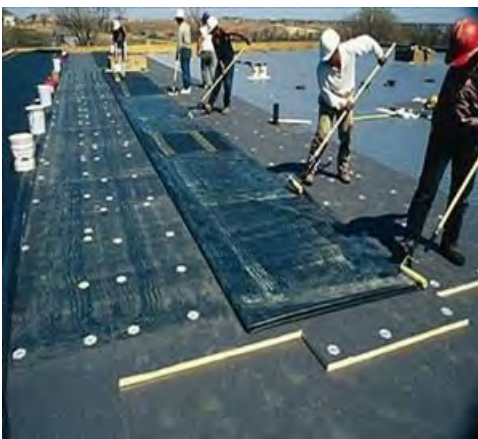
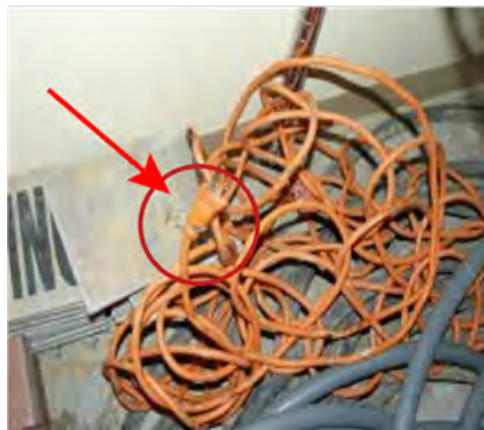
Damaged cord

- *Inspect extension cords with each use and make sure worn or frayed electric cords are removed from service [reference 1926.416(e)(1)]. Ideally, damaged cords should be completely removed from the work area and tagged DO NOT USE or discarded. [View OSHA Standard](#)*

- Note: Most cords were in good condition. This is the only cord found with damage.
 - Severity Rating: Moderate
 - Responsible Party: Best Contractor
- *Instruct workers to keep electrical cords reasonably clear of working spaces, walkways or similar areas to minimize trip/fall hazard and to protect cords from damage [reference 1926.416(b)(2)]. Consider re-routing cords away from active work areas or eliminating cords that are no longer needed. In some situations, it may be necessary to suspend cords or bury them in plastic conduit to protect them. [View OSHA Standard](#)*

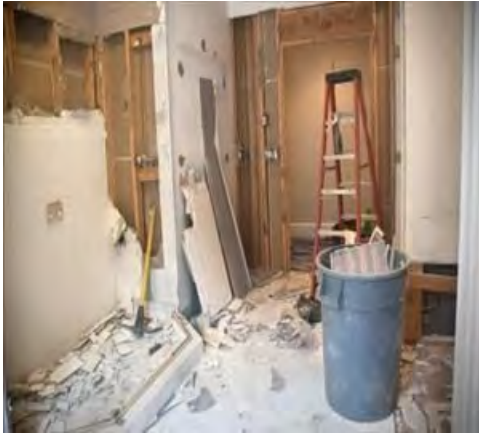
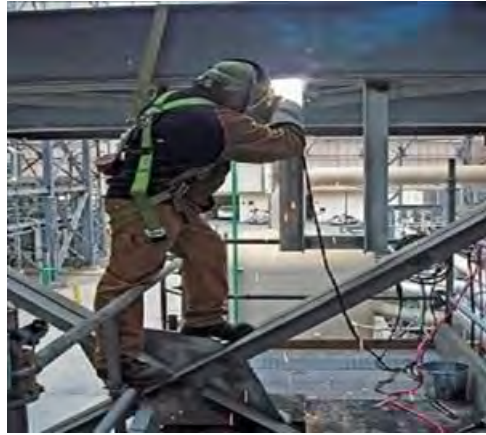
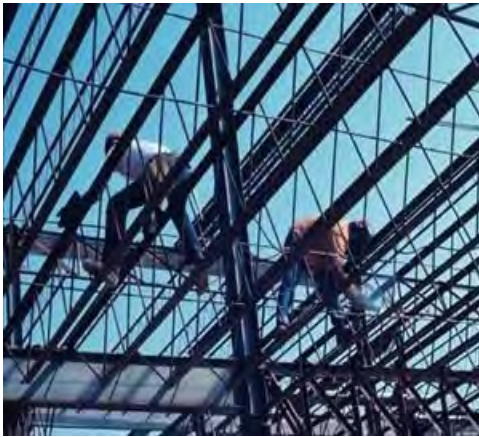
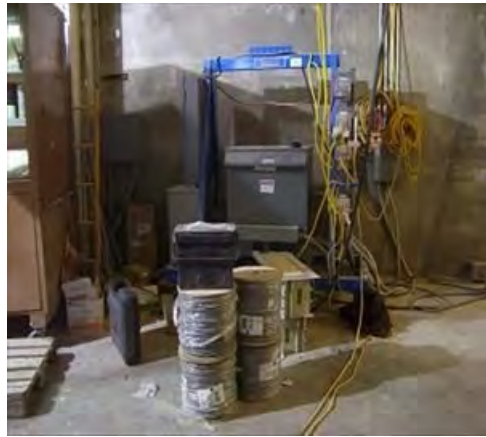
Extremely poor houskeeping

- *Take steps to ensure all work areas, passageways, and stairs are kept reasonably clean, orderly and free of scrap lumber, trash, debris, cords, etc. [reference 1926.25]. [View OSHA Standard](#)*
 - Severity Rating: Serious
 - Responsible Party: Best Contractor, Drake's Drywall
- *Scrap lumber with protruding nails shall be kept cleared from work areas, passageways, and stairs, in and around buildings or other structures [reference 1926.25(a)]. [View OSHA Standard](#)*
 - Note: Found several boards in scrap lumber pile with protruding nails.
 -
 - Responsible Party: Panther Construction, Stonewall Construction

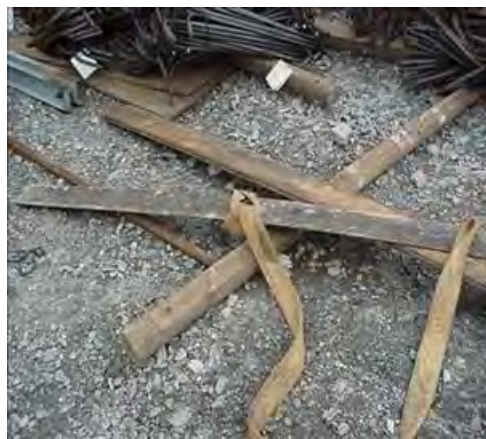
Located near lay down area

- *The site layout must have a firm, properly graded and drained area with adequate space for the safe storage of materials and the safe operation of the erectors equipment [reference 1926.752(c)(2)]. [View OSHA Standard](#)*
 - Note: Lay down yard needs to be relocated or graded to remove water.
 - Responsible Party: E.J. Erectors

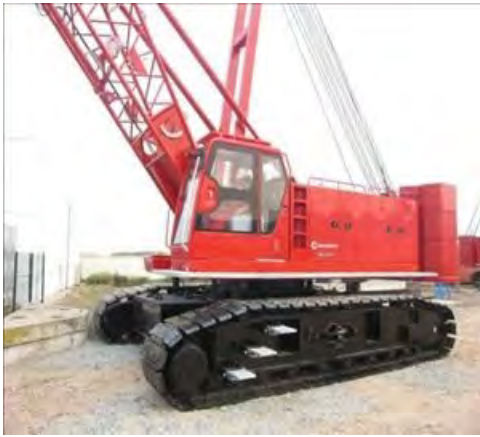
Radius guard not installed.

- *Make sure all accessible areas within swing radius of crane are barricaded to prevent workers from being struck or crushed [reference 1926.1424(a)]. [View OSHA Standard](#)*
 - Note: Radius guard is installed but not flagged per policy.
 -
 - Severity Rating: Advisory
 - Responsible Party: Master Construction

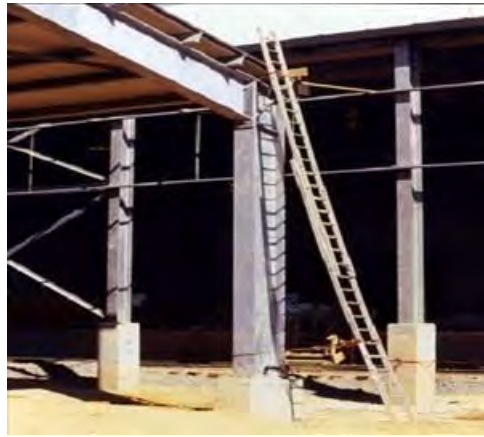
Spec tags missing

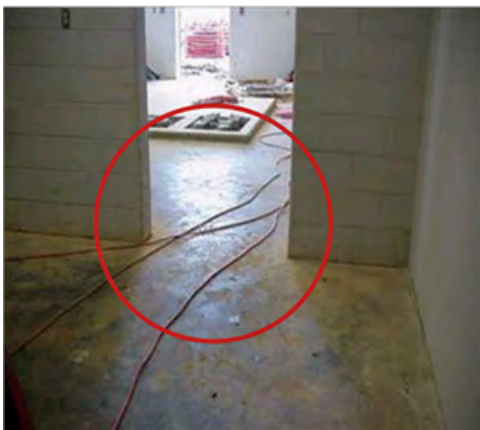
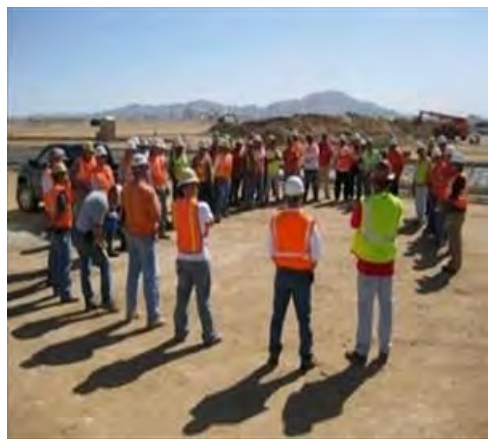
Trip hazard, cords need to be rerouted.

- Note: Remove cord or suspend it to keep out of water and pedestrian traffic.
 - Severity Rating: Minor
 - Responsible Party: Master Construction

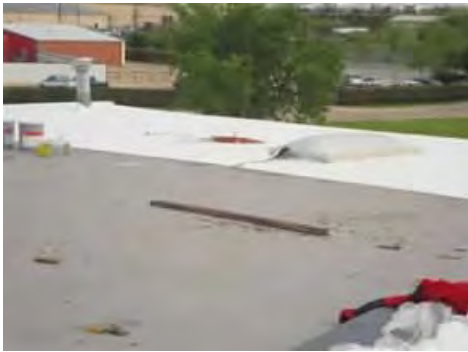
No warning line erected on north end of roof.

- *When using Personal Fall Arrest Systems to meet OSHA's six foot fall protection standard, the PFA system must be rigged such that the employee does not come in contact with the lower level [reference 1926.502(d)(16)(iii)]. [View OSHA Standard](#)*
 - Note: Should be using a retractable. The
 - 6 lanyard and choker not working.
 - Severity Rating: Critical
 - Contributing Factor: Training
 - Responsible Party: E.J. Erectors
- *When performing roofing activities, the control line shall be erected not less than 6 feet nor more than 25 feet from all unprotected or leading edges of roof surfaces [reference 1926.502(g)(1)(i)]. [View OSHA Standard](#)*
 - Responsible Party: Atta Boy Roofing
