Re: Construction Safety Survey
Omaha, NE

Report Name: Construction Safety Survey
Completed for: Best Company
Inspection Date: July 23, 2018
Location: Omaha, NE
Contact: Bill Smith, Superintendent
Job Number: 12345
Project Manager: Tim Miller
Region: Midwest
Score: 61.4%

Scope of Work: Construction Site Safety Inspection

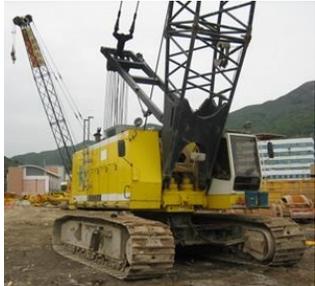
Issue Identified Accessible areas within swing radius of crane are not barricaded to prevent workers from being struck or crushed (1926.1424)

Notes: Observed 3 crawler cranes on site and two of them did not have guards.

Radius guard is missing

Radius guard is missing on this crane

This crane has radius guard, but it should be flagged

Recommendation *All accessible areas within the swing radius of a crane shall be barricaded to prevent workers from being struck or crushed. Take appropriate action to address issues of non-compliance. [reference 1926.1424(a)] [View OSHA Standard](#)*

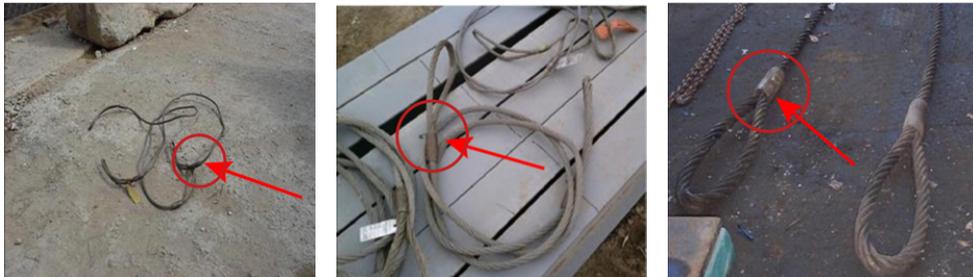
Issue Identified **Not all rigging equipment is properly tagged/labeled with required markings (1926.251)**

Notes: Spec tags missing on several wire rope slings

Recommendation *Employers must ensure that all rigging equipment (i.e. slings, fastenings, attachments, etc.) has permanently affixed and legible identification markings as prescribed by the manufacturer that indicate the recommended safe working load. Rigging equipment shall not be used if markings are missing or illegible. [reference 1926.251(a)(2)(i) and (iii)] [View OSHA Standard](#)*
