Re: Construction Safety Survey  
Omaha, NE

Report Name: Construction Safety Survey  
Completed for: Best Company  
Inspection Date: July 23, 2018  
Location: Omaha, NE  
Contact: Bill Smith, Superintendent  
Job Number: 12345  
Project Manager: Tim Miller  
Region: Midwest  
Score: 61.4%

**Scope of Work:** Construction Site Safety Inspection

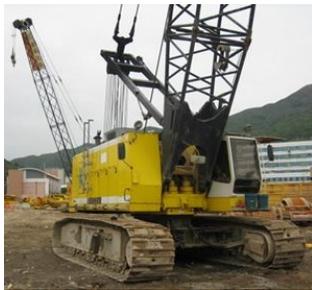
**Issue Identified** Accessible areas within swing radius of crane are not barricaded to prevent workers from being struck or crushed (1926.1424)

**Notes:** Observed 3 crawler cranes on site and two of them did not have guards.

Radius guard is missing

**Recommendation** All accessible areas within the swing radius of a crane shall be barricaded to prevent workers from being struck or crushed. Take appropriate action to address issues of non-compliance. [reference 1926.1424(a)] [View OSHA Standard](#)

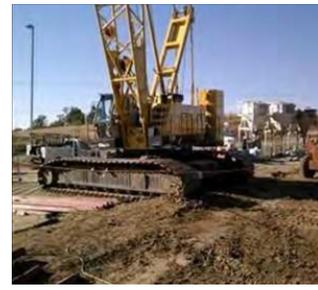
This crane has radius guard, but it should be flagged
