Re: Construction Safety Survey  
Omaha, NE

Report Name: Construction Safety Survey  
Completed for: Best Company  
Inspection Date: July 23, 2018  
Location: Omaha, NE  
Contact: Bill Smith, Superintendent  
Job Number: 12345  
Project Manager: Tim Miller  
Region: Midwest  
Score: 61.4%

**Scope of Work:** Construction Site Safety Inspection

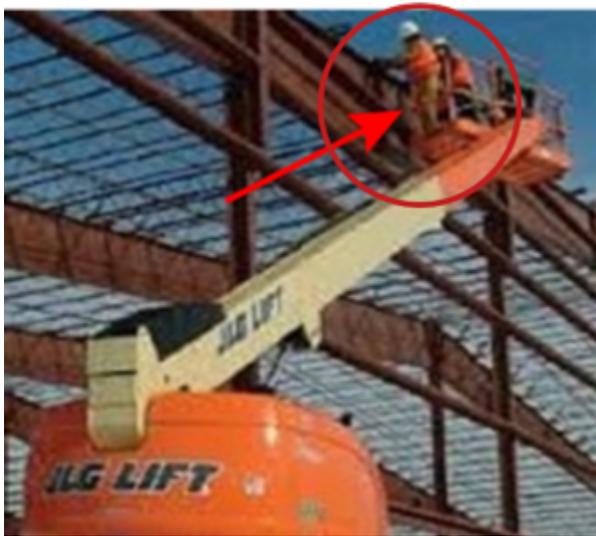
- Workers in aerial lift are tied off to an approved anchorage point (1926.453)
- Only trained and/or authorized operators are allowed to use aerial lifts (1926.453)
- **Worker(s) observed standing on toeboard or rail of lift, did not keep both feet on floor of basket (1926.453) (See Photo)**  
*Note: Worker observed standing on mid-rail of JLG*
- Aerial lift is stationary when boom or basket is elevated with workers in it (1926.453)
- Aerial lifts are inspected daily/prior to use and inspections are documented (1926.453)

Observed one of the ironworkers standing on midrail when I arrived.

- *When working from an aerial lift, employees must stand firmly on the floor of the basket and not be allowed to step or climb on toeboard or railing of basket or use planks, ladders or other devices for a work position. Take appropriate steps to maintain compliance with this requirement. [reference 1926.453(b)(2)(iv)] [View OSHA Standard](#)*
  - Note: Worker observed standing on mid-rail of JLG
  - Responsible Party: E.J. Erectors

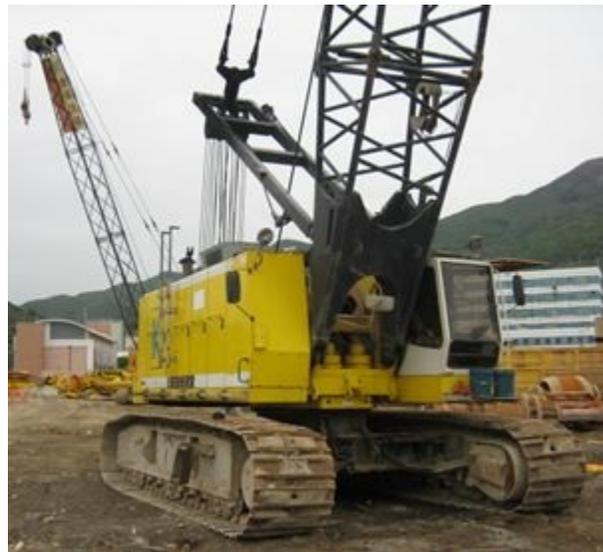
- Required safety devices (i.e. level indicator, boom/jib stops, stabilizer holding device/check valve, horn, etc.) are installed and maintained (1926.1415)
- A visual inspection by a competent person is completed each shift the equipment is used (1926.1412)
- Signals (hand, voice, audible, etc.) and means of transmitting signals to the operator (direct line of sight, video, radio, etc.) are established (1926.1419)
- **Accessible areas within swing radius of crane are not barricaded to prevent workers from being struck or crushed (1926.1424) (See Photo)**  
*Note: Observed 3 crawler cranes on site and two of them did not have guards.*

Radius guard is missing

- *All accessible areas within the swing radius of a crane shall be barricaded to prevent workers from being struck or crushed. Take appropriate action to address issues of non-compliance. [reference 1926.1424(a)] [View OSHA Standard](#)*
  - Note: Observed 3 crawler cranes on site and two of them did not have guards.
  - Severity Rating: Advisory
  - Responsible Party: Master Construction

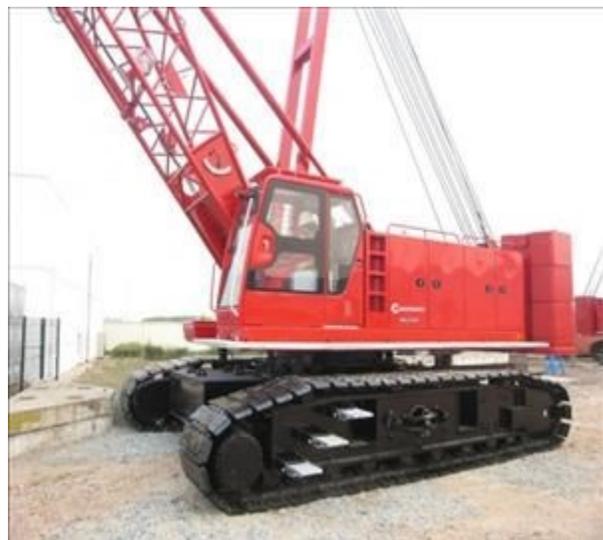
Radius guard is missing on this crane

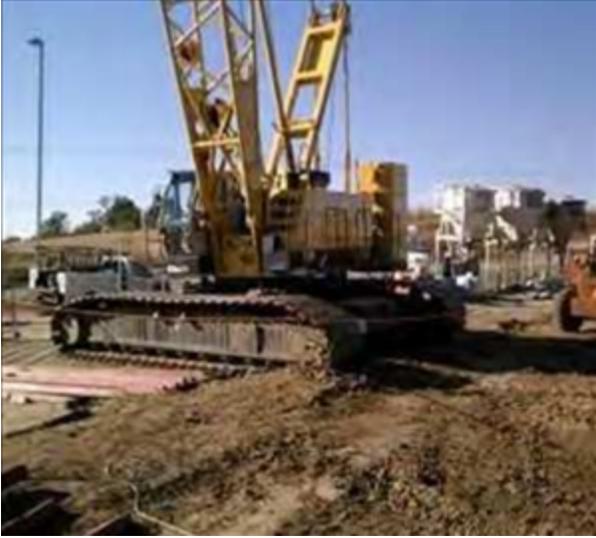
This crane has radius guard, but it should be flagged

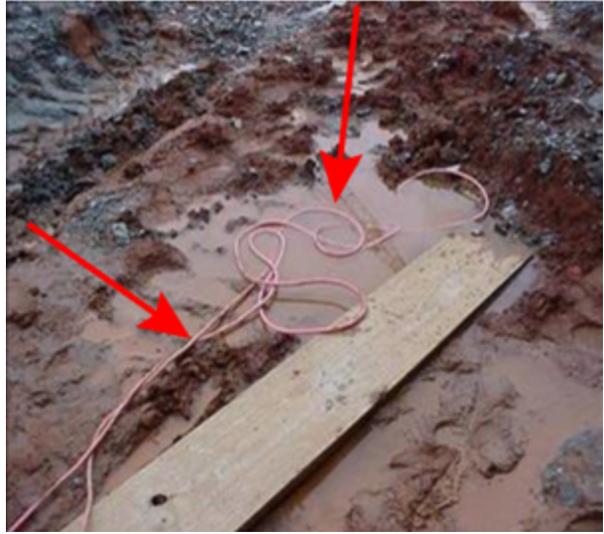
**Note:** Cord near job trailer needs to be relocated.

Flexible cord near job trailer should be relocated

- *Instruct workers to keep electrical cords reasonably clear of working spaces, walkways or similar areas to minimize trip/fall hazard and to protect cords from damage [reference 1926.416(b)(2)]. Consider re-routing cords away from active work areas or eliminating cords that are no longer needed. In some situations, it may be necessary to suspend cords (using an approved method) or bury them (using an approved protective cover) to minimize risk of damage or electrical shock. [View OSHA Standard](#)*
  - Note: Cord near job trailer needs to be relocated.
  - Responsible Party: Master Construction

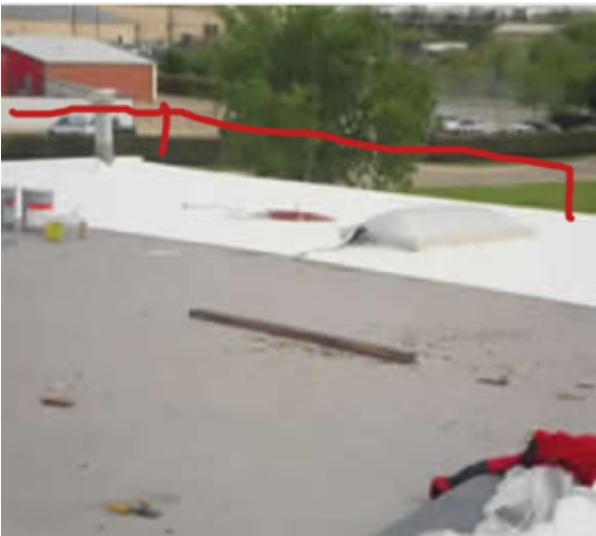
- Floor hole covers are secured, capable of supporting 2x maximum load, and appropriately marked (1926.502)
- **Control lines are not erected at least 6 back feet from all unprotected/leading edges when erecting precast concrete members (1926.502) (See Photo)**  
*Note: Need to reevaluate worksite and install control lines as required (specifically along north edge of roof on main building)*

Need warning lines installed in area marked in red

- Note: Need to reevaluate worksite and install control lines as required (specifically along north edge of roof on main building)
- Severity Rating: Serious
- Responsible Party: Atta Boy Roofing

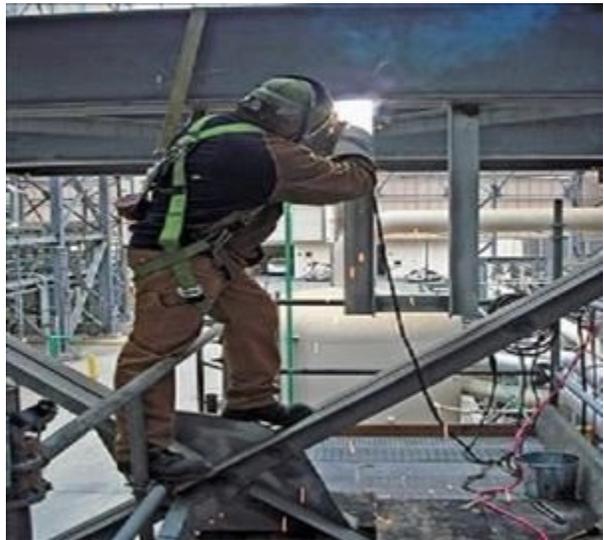
- **The PFA System does not protect employee(s) from coming in contact with lower level (1926.502) (See Photo)**  
*Note: There were a couple of instances where a retractable lanyard would have been a better option versus 6' lanyard in order to limit fall distance.*

Consider alternative tie-off method (i.e. retractable to limit fall distance)

- *When using Personal Fall Arrest Systems, the PFA system must be rigged such that an employee does not contact any lower level if they should fall. Take steps to address deficiencies as noted in report. [reference 1926.502(d)(16)(iii)] [View OSHA Standard](#)*
  - Note: There were a couple of instances where a retractable lanyard would have been a better option versus 6' lanyard in order to limit fall distance.
  - Severity Rating: Serious
  - Responsible Party: E.J. Erectors
- *When erecting precast concrete members, the control line shall be erected not less than 6 feet nor more than 60 feet or half the length of the member being erected, whichever is less, from the*

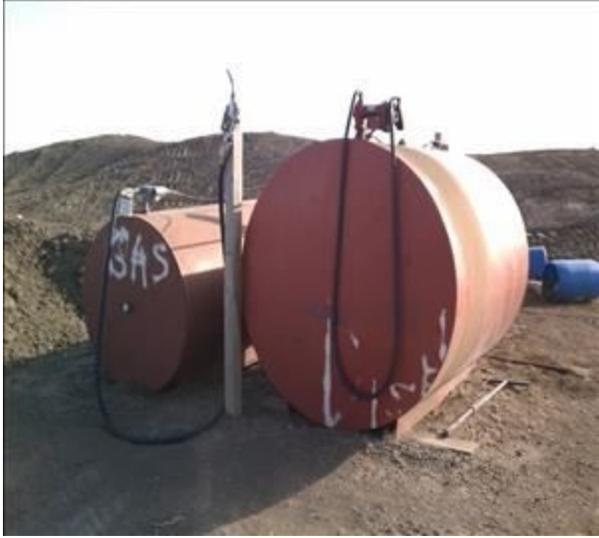
- **Fuel tanks are not properly labeled/identified (NFPA 30) (See Photo)**  
*Note: Contact fuel supplier to have them label fuel tanks*

Fuel tanks are not properly labeled

- *Take steps to ensure fuel tanks are properly labeled and/or identified with fuel name stenciled on tank, flammable placards, etc. per requirements in NFPA 30 and/or applicable local/state codes.*
  - Note: Contact fuel supplier to have them label fuel tanks
  - Severity Rating: Advisory
  - Responsible Party: Panther Construction

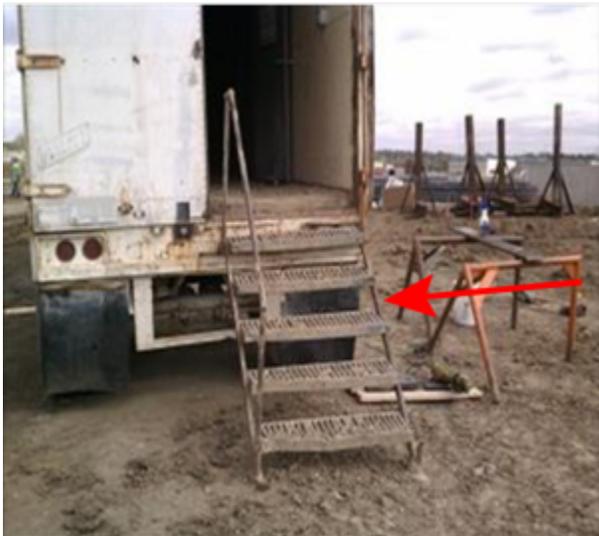
Electrical Contractor Trailer

- Note: Stairs to electrical contractor storage trailer need a handrail
  - Responsible Party: Able Electric

- Responsible Party: Best Contractor
- *Take steps to ensure all stairways having four or more risers or rising more than 30 inches, whichever is less, are equipped with at least one handrail or two if both sides are open. [reference 1926.1052(c)] [View OSHA Standard](#)*

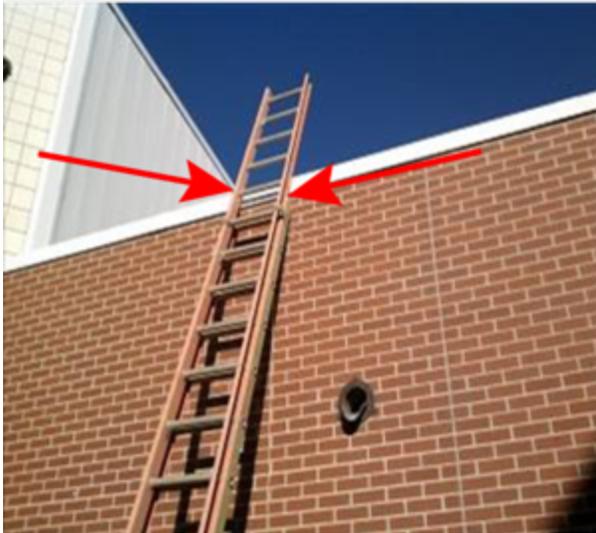
Ladder not secured

- Note: Ladder is sagging, doesn't appear to be set at proper angle
  - Responsible Party: E.J. Erectors
- *Take appropriate steps to ensure ladder side rails are secured to a rigid support to prevent the top of ladder from shifting (i.e. slipping sideways and possibly falling over). [reference 1926.1053(b)(1)] [View OSHA Standard](#)*

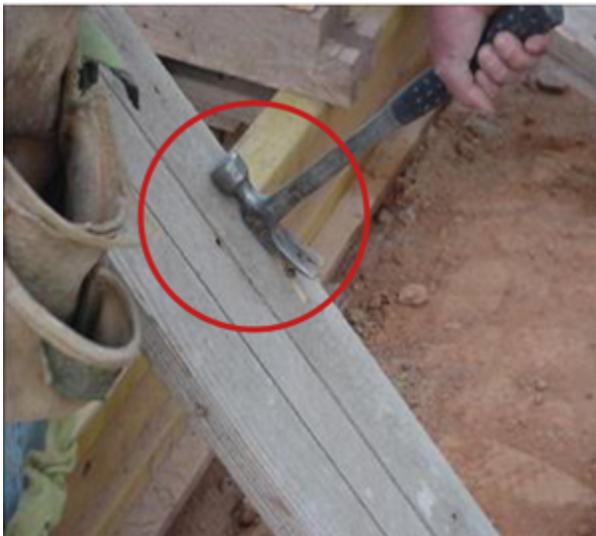
Nails were removed or bent down on several boards of scrap lumber

- *Take steps to ensure all work areas, passageways, and stairs are kept reasonably clean, orderly and free of scrap lumber, trash, debris, cords, etc. [reference 1926.25(a)]. [View OSHA Standard](#)*
  - Note: Housekeeping throughout worksite needs to be improved.
  - Severity Rating: Moderate
  - Responsible Party: Best Contractor, Drake's Drywall, Spellman Construction
- *Scrap lumber with protruding nails shall be kept cleared from work areas, passageways, and stairs, in and around buildings or other structures [reference 1926.25(a)]. [View OSHA Standard](#)*
  - Severity Rating: Moderate
  - Responsible Party: Panther Construction

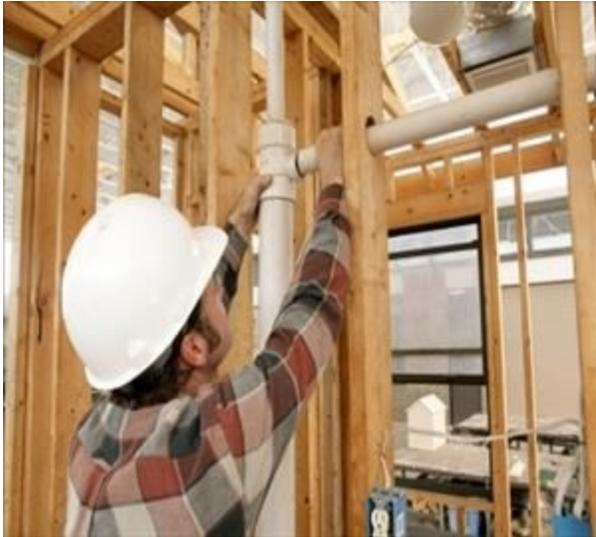
- **Not all employees used ANSI approved eye protection as required (1926.102) (See Photo)**  
*Note: Overall, use of eye/face protection was good, but found plumber not wearing safety glasses*
- Face protection is used when sawing, cutting, grinding, welding, etc. (1926.102) **(See Photo)**
- Hard hats are worn as required (1926.100)
- Appropriate safety footwear is worn as required (1926.28)
- Hearing protection is provided/used as required (1926.52)

Contractor not wearing safety glasses

- *Take steps to ensure employees are provided with and required to wear appropriate eye protection equipment (i.e. ANSI approved) for the task whenever the potential for eye injury exists. [reference 1926.102(a)(1)] [View OSHA Standard](#)*
  - Note: Overall, use of eye/face protection was good, but found plumber not wearing safety glasses
  - Responsible Party: Columbia Plumbing

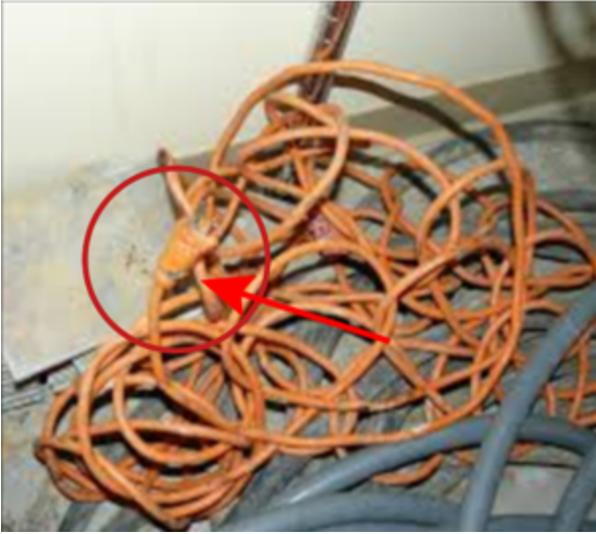
This cord was removed from service

- *Inspect electric cords or cables with each use and make sure worn or frayed cords are removed from service [reference 1926.416(e)(1)]. Ideally, damaged cords/cables should be completely removed from the work area and tagged DO NOT USE or they should be properly discarded (i.e. rendered unusable/cut in half, placed in trash receptacle). [View OSHA Standard](#)*
  - Note: Several cords were observed and most were in good condition, with the exception of the one pictured in this report. It was immediately removed from service.
  - Responsible Party: Best Contractor

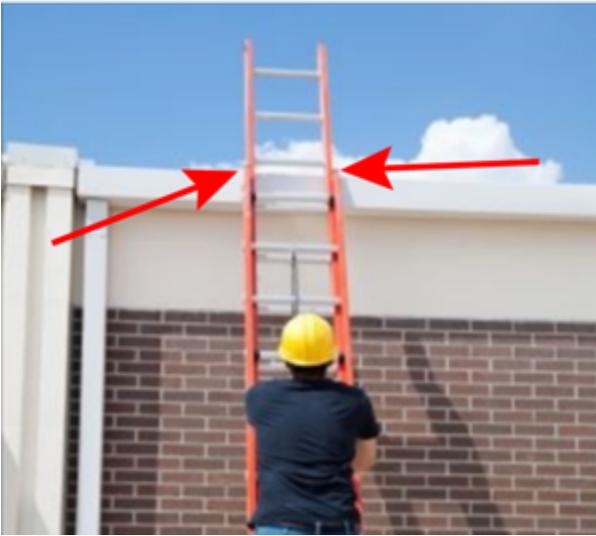
Ladder needs to be tied off
