Re: City Bank Safety Survey  
Atlanta, GA

## Report Summary

Report Name: City Bank  
Completed for: Construction, Inc.  
Inspection Date: May 20, 2021  
Location: Atlanta, GA  
Contact: Ron Thompson, Manager  
Project Manager: Bill Jones  
Project Number: 3494595  
Score: 85.6%  
Weather: Omaha, NE on 07/23/2021 11:55 AM  
Haze. Temp: 86° F, Feels Like: 89° F, Humidity: 55.08%  
Wind: S 9 mph

**Scope of Work:** New construction

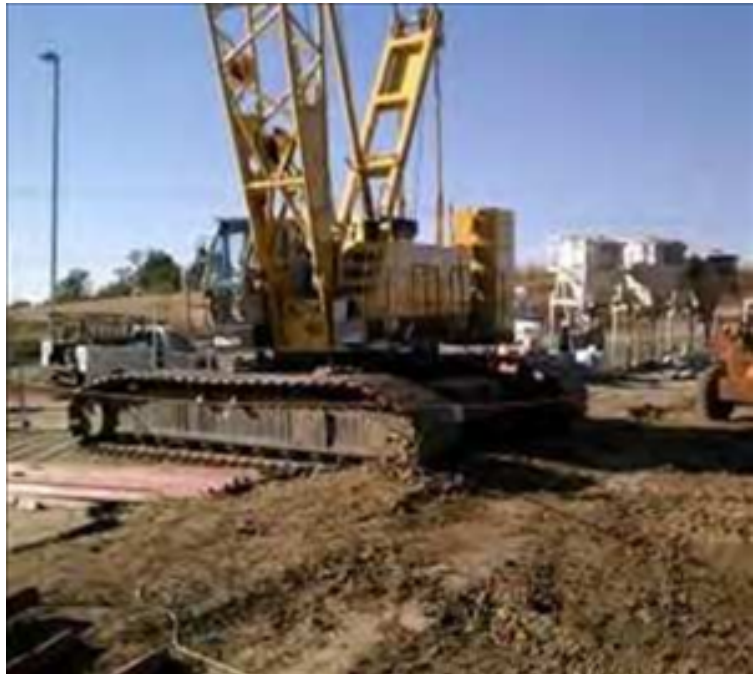
**Issue Identified:** Accessible areas within swing radius of crane are not barricaded to prevent workers from being struck or crushed (1926.1424) (See Photo)

**Notes:** A rope barrier is installed but it should be flagged.

**Severity:** Advisory (negligible impact)

Radius guard should be flagged to help increase visibility

**Recommendation:** All accessible areas within the swing radius of a crane shall be barricaded to prevent workers from being struck or crushed. Take appropriate action to address issues of non-compliance. [reference 1926.1424(a)] [View OSHA Standard](#)

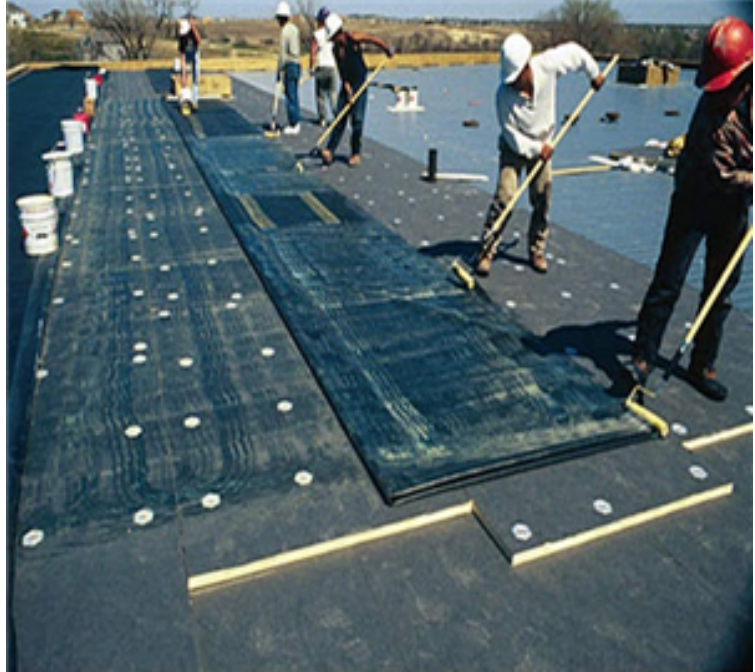
**Issue Identified:** Warning line is not erected around all open/unprotected sides of the roof edge (1926.502) (See Photo)

**Notes:** No warning lines were setup.

**Severity:** Moderate (marginal impact)

**Recommendation:** When using a warning line system, take steps to ensure it is erected around all open sides of the working surface where a fall hazard may exist such as a hole large enough to fall through, unprotected leading edge or an exposed roof ledge. Periodically inspect the warning line to ensure it's maintained as required. [reference 1926.502(f)(1)] [View OSHA Standard](#)

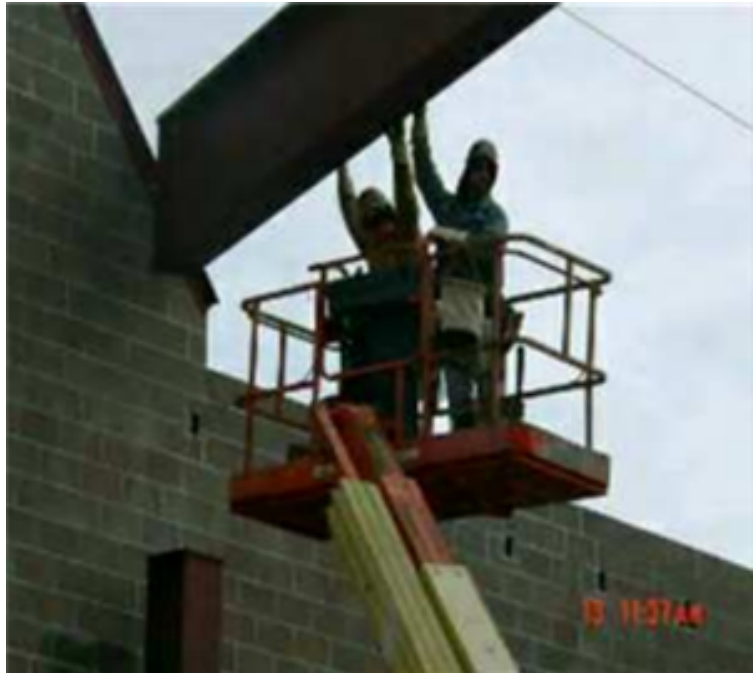
**Issue Identified:** Workers do not use harness/lanyard tied to approved anchor when working in basket (1926.453) (See Photo)

**Notes:** Observed two workers in basket of JLG, one was tied off, the other forgot to connect his lanyard. Met with the jobsite Superintendent and this was immediately corrected. Disciplinary action pending.

**Severity:** Serious/Extreme (deducts 5%)

**Recommendation:** Instruct and require workers to wear a full body harness and lanyard attached to an "approved" anchorage point within the basket when working from a Mobile Elevated Work Platform. Take appropriate steps to ensure 100% compliance with this requirement. [reference 1926.453(b)(2)(v)] [View OSHA Standard](#)

**Corrected:** Item(s) noted above were corrected immediately! No further action required.

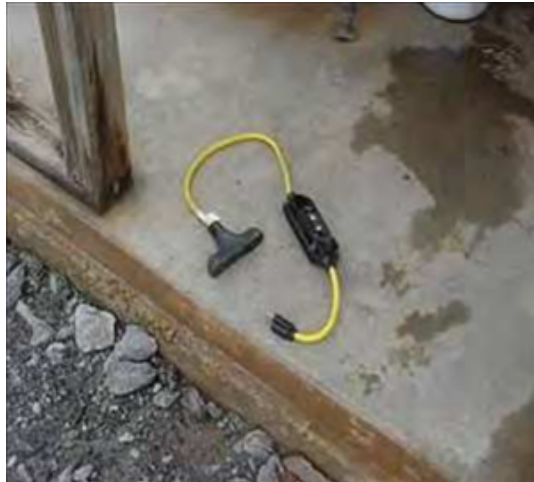
Photo(s)

- Positive Finding** Ground pins are attached to electrical cords (i.e. extension cords and/or flexible cord sets) (1926.404)
- Positive Finding** GFCI is used for temporary power connections (1926.404)

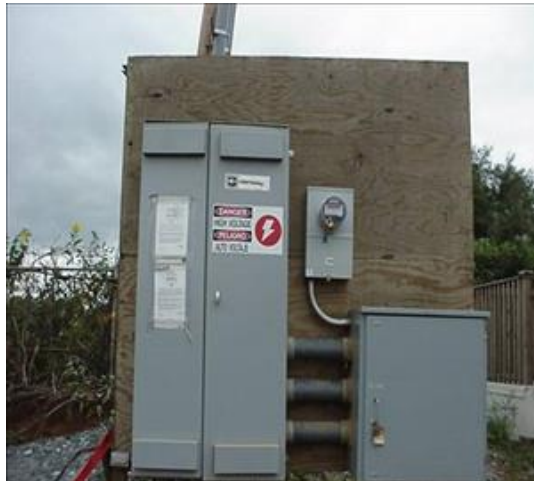
Photo(s)

- Positive Finding** Flexible cords are maintained in good condition (1926.416)
- Positive Finding** Electrical cords are protected/kept clear of working spaces and walkways (1926.416)
- Positive Finding** Electrical panels/circuits are effectively enclosed (1926.405)

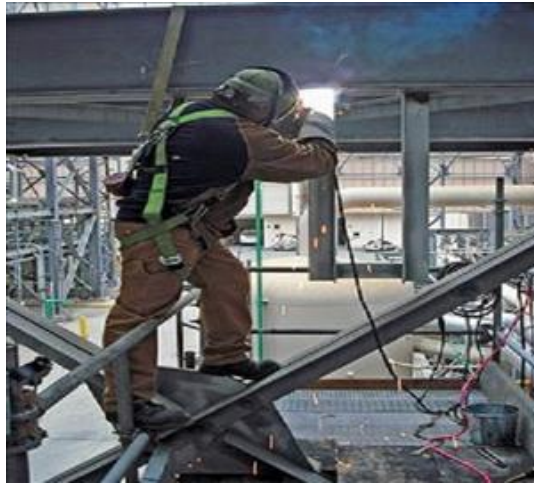
Photo(s)

- Positive Finding** Suitable anchorage is provided and used for personal fall arrest system (1926.502)

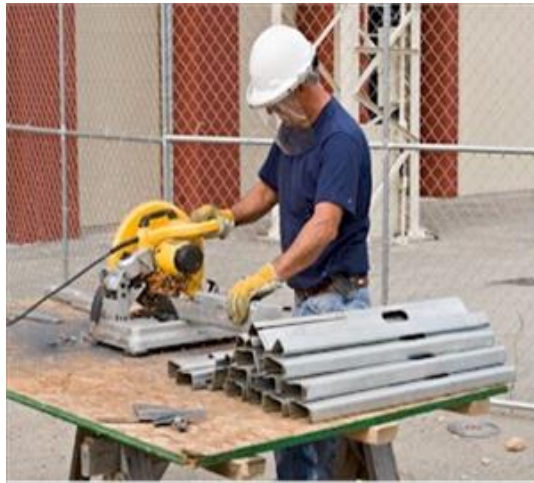
Photo(s)

- Positive Finding** Appropriate PPE is used/worn as required (1926.95)
- Positive Finding** Eye protection is worn as required (1926.102)
- Positive Finding** Face protection is used when required (1926.102)

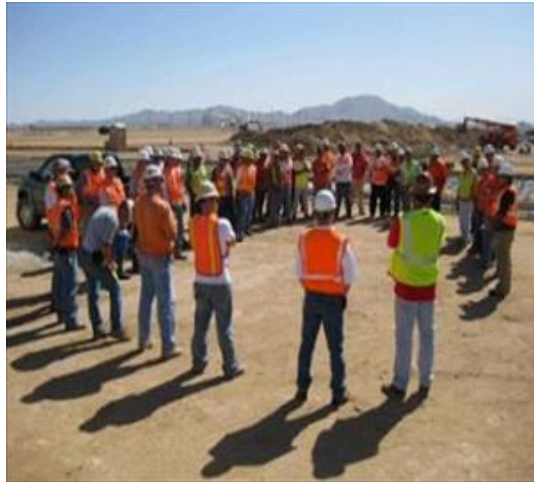
**Photo(s)**

**Positive Finding** Toolbox talks are completed weekly per company policy (1926.21)
