Re: Construction Safety Survey
Omaha, NE

Construction Report

Completed for: Best Company
 Report Name: Construction
 Location: Omaha, NE
 Contact: Bob Jones, Superintendent
 Project #: 12355

Inspection Date: October 02, 2016

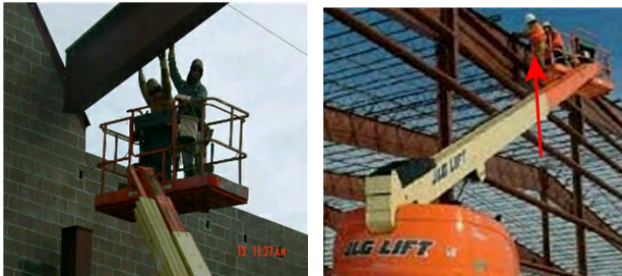
Aerial/Boom Lifts	Yes	No
• Workers tied off to approved anchorage point in basket? 1926.453(b)(2)(v)	✓	
• Operator(s) trained and/or authorized? 1926.453(b)(2)(ii)	✓	
• Both feet on floor of basket? 1926.453(b)(2)(iv) (See Photo) <i>Note: Worker observed with one foot on mid rail</i>		✓
• Aerial lift stationary when elevated? 1926.453(b)(2)(viii)	✓	
• Operated on level surface per equipment specs? (ANSI/SIA A92.5)	✓

Workers have both feet on floor of lift

- *When working from an aerial lift, employees must stand firmly on the floor of the basket and not be allowed to step or climb on toeboard or railing of basket or use planks, ladders or other devices for a work position [reference 1926.453(b)(2)(iv)]. [View OSHA Standard](#)*
 - Note: Worker observed with one foot on mid rail
 - Responsible Party: E.J. Erectors

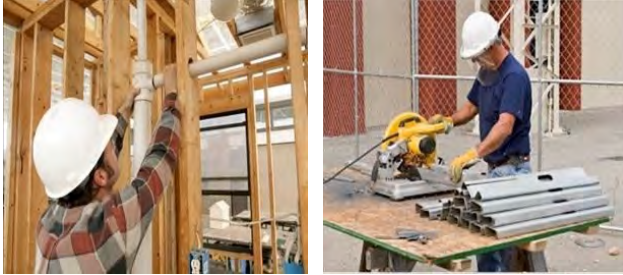
- Safety footwear worn as needed? 1926.28(a) ✓
- Hearing protection used as required? 1926.52(a) ✓
- High-visibility clothing worn as required? 1926.28(a) ✓
- Face protection used when required? 1926.102(a)(1) **(See Photo)** ✓

Not wearing safety glasses or gloves

- *Provide appropriate PPE and/or require that PPE be used at each work site to protect employees against known hazards [reference 1926.95(a)]. [View OSHA Standard](#)*
 - Responsible Party: Columbia Plumbing

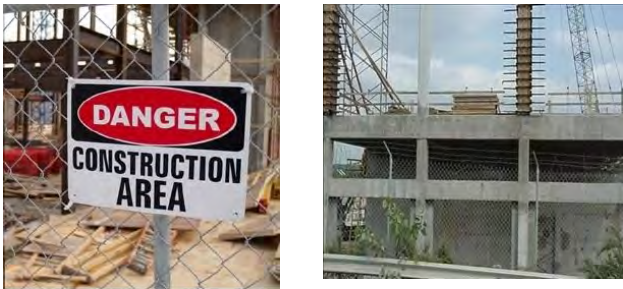
Public Protection	Yes	No
• Public exposure to airborne contaminants (dust/fumes/smoke) controlled? 3.2.2	✓	
• Construction operations near pedestrian/vehicular traffic controlled? 3.2.3	✓	
• Areas where public is exposed to mobile equipment are barricaded/guarded? 3.2.7.2	✓	
• Barriers, enclosures, netting used to protect public from falling/wind-borne objects? 3.2.8	✓	
• Measures taken to restrict public access to jobsite? 3.2.9 (See Photo)	✓	
• Operations generating waste/debris controlled to minimize exposure to adjacent areas? 3.2.10	✓

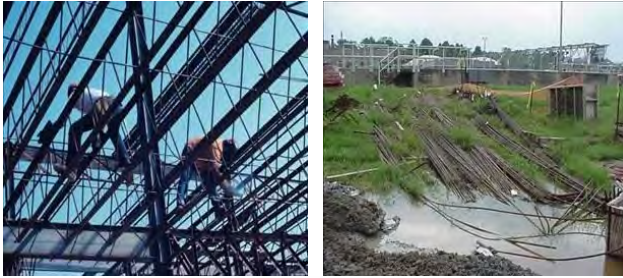
- **Site layout graded, drained and adequate space? 1926.752(c)(2) (See**

Note: Lay down yard needs to be relocated or graded to remove water.

- *The site layout must have a firm, properly graded and drained area with adequate space for the safe storage of materials and the safe operation of the erectors equipment [reference 1926.752(c)(2)]. [View OSHA Standard](#)*
 - Note: Lay down yard needs to be relocated or graded to remove water.
 - Responsible Party: E.J. Erectors
