# SAFETY REPORTS

Re: Construction Safety Survey  
Omaha, NE

## Construction Report

Completed for: Best Company  
Report Name: Construction  
Location: Omaha, NE  
Contact: Bob Jones, Superintendent  
Project #: 12355

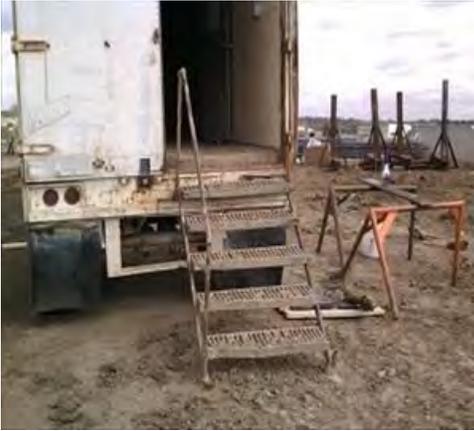
- **Handrail(s) are not provided as required on stairs with 4 or more risers (1926.1052) (See Photo)**
- 9) PPE
- **Appropriate PPE is not always provided and/or used as required (1926.95) (See Photo)**

Need handrail on steps to storage trailer

- Responsible Party: Best Contractor, E.J. Erectors
- *Stairways having four or more risers or rising more than 30 inches, whichever is less, shall be equipped with at least one handrail or two if both sides are open [reference 1926.1052(c)]. Provide handrails as required. [View OSHA Standard](#)*
  - Responsible Party: Columbia Plumbing

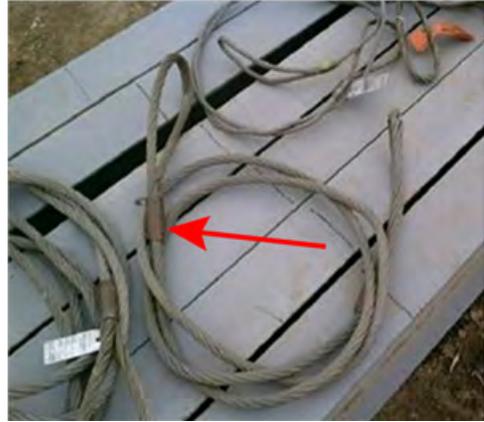
- Rigging equipment is maintained in good condition and damaged/defective equipment is removed from service (1926.251)
- **Not all rigging equipment is properly tagged/labeled with required markings (1926.251) (See Photo)**
- Rigging equipment is used per manufacturer's specifications (Best Practice)
- Rigging equipment is properly stored when not in use (Best Practice)

Specification tag missing

- *Employers must ensure that all rigging equipment (i.e. slings, fastenings, attachments, etc.) has permanently affixed and legible identification markings as prescribed by the manufacturer that indicate the recommended safe working load. Rigging equipment shall not be used if markings are missing or illegible. [reference 1926.251(a)(2)(i) and (iii)] [View OSHA Standard](#)*
  - Responsible Party: Best Contractor

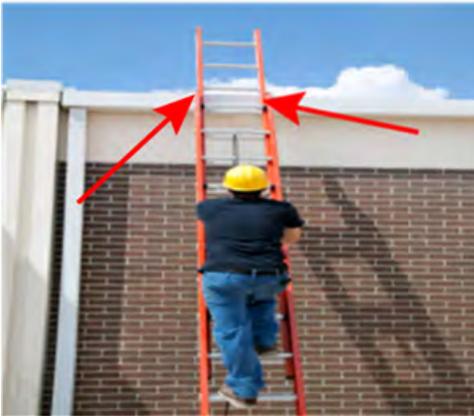
Not wearing safety glasses or gloves

- *Provide appropriate PPE and/or require that PPE be used at each work site to protect employees against known hazards [reference 1926.95(a)]. [View OSHA Standard](#)*
  - Responsible Party: Columbia Plumbing

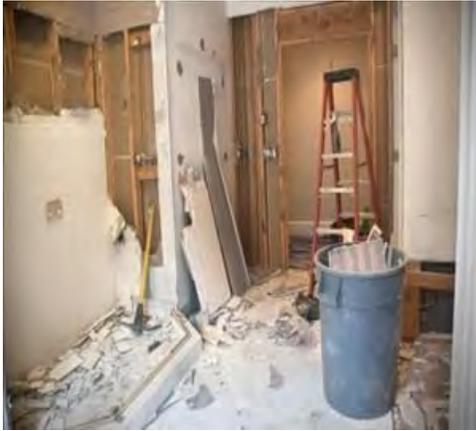
- 7) Housekeeping
- **Housekeeping is unacceptable/needs improvement (1926.25) (See Photo)**
  - **Workers are exposed to scrap lumber with protruding nails (1926.25) (See Photo)**  
*Note: Found several boards in scrap lumber pile with protruding nails.*

Extremely poor houskeeping

- *Take steps to ensure all work areas, passageways, and stairs are kept reasonably clean, orderly and free of scrap lumber, trash, debris, cords, etc. [reference 1926.25]. [View OSHA Standard](#)*
  - Severity Rating: Serious
  - Responsible Party: Best Contractor, Drake's Drywall
- *Scrap lumber with protruding nails shall be kept cleared from work areas, passageways, and stairs, in and around buildings or other structures [reference 1926.25(a)]. [View OSHA Standard](#)*
  - Note: Found several boards in scrap lumber pile with protruding nails.
  - 
  - Responsible Party: Panther Construction, Stonewall Construction

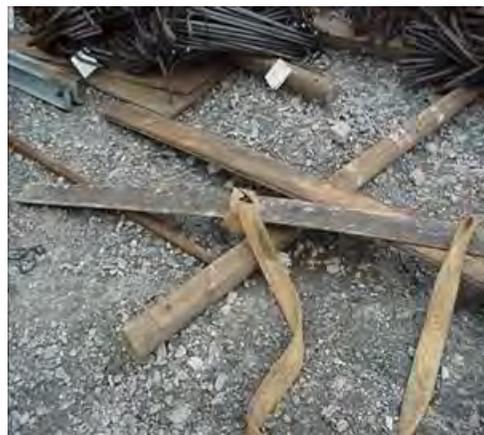
Located near lay down area

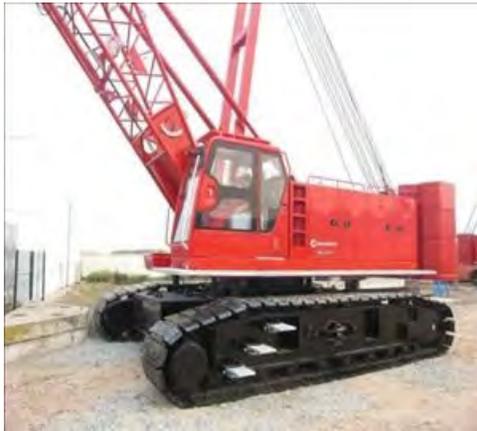
- Required safety devices (i.e. level indicator, boom/jib stops, stabilizer holding device/check valve, horn, etc.) are installed and maintained (1926.1415)
- Required operational aides (i.e. boom angle/radius indicator, boom/jib hoist limiting device, anti two-blocking device, etc.) are installed and maintained (1926.1416)
- A visual inspection by a competent person is completed each shift the equipment is used (1926.1412)
- Signals (hand, voice, audible, etc.) and means of transmitting signals to the operator (direct line of sight, video, radio, etc.) are established (1926.1419)
- **Accessible areas within swing radius of crane are not barricaded to prevent workers from being struck or crushed (1926.1424) (See Photo)**  
*Note: Radius guard is installed but not flagged per policy.*

Radius guard not installed.

- *Make sure all accessible areas within swing radius of crane are barricaded to prevent workers from being struck or crushed [reference 1926.1424(a)]. [View OSHA Standard](#)*
  - Note: Radius guard is installed but not flagged per policy.
  - 
  - Severity Rating: Advisory
  - Responsible Party: Master Construction

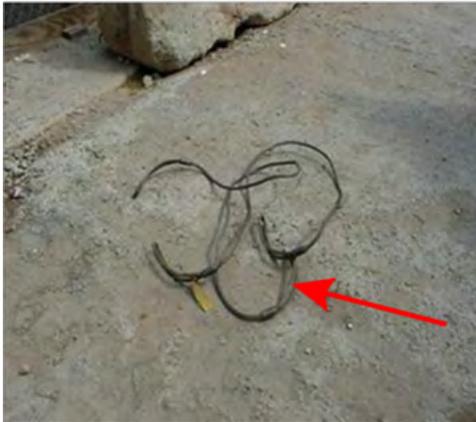
Specification tag missing

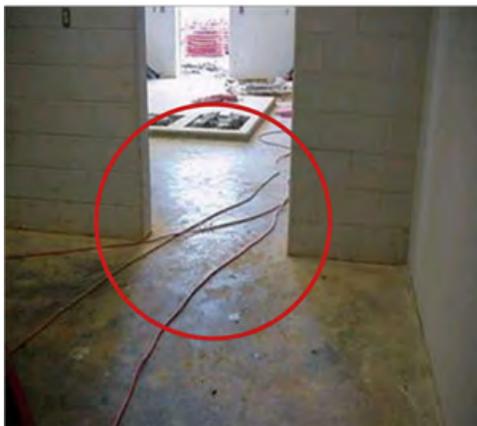
- GFCI is used for temporary power connections (1926.404) **(See Photo)**  
*Note: Good use of GFCI*
- **Extension cord(s) in poor condition, i.e. worn or frayed (1926.416) (See Photo)**  
*Note: Most cords were in good condition. This is the only cord found with damage.*
- **Cords not protected/kept clear of working spaces and walkways (1926.416) (See Photo)**  
*Note: Remove cord or suspend it to keep out of water and pedestrian traffic.*
- Electrical panels/circuits are effectively enclosed (1926.405) **(See Photo)**

Trip hazard, cords need to be rerouted.

- *Instruct workers to keep electrical cords reasonably clear of working spaces, walkways or similar areas to minimize trip/fall hazard and to protect cords from damage [reference 1926.416(b)(2)]. Consider re-routing cords away from active work areas or eliminating cords that are no longer needed. In some situations, it may be necessary to suspend cords or bury them in plastic conduit to protect them. [View OSHA Standard](#)*

- Note: Remove cord or suspend it to keep out of water and pedestrian traffic.
  - Severity Rating: Minor
  - Responsible Party: Master Construction

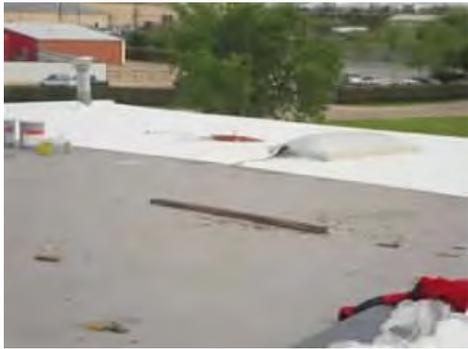
- Floor hole covers are secured, capable of supporting 2x maximum load, and appropriately marked (1926.502) **(See Photo)**
  - **Control lines are not erected at least 6 back feet from all unprotected/leading edges of low-sloped roofs during roofing activities (1926.502) (See Photo)**

No warning line erected on north end of roof.

- *When using Personal Fall Arrest Systems to meet OSHA's six foot fall protection standard, the PFA system must be rigged such that the employee does not come in contact with the lower level [reference 1926.502(d)(16)(iii)]. [View OSHA Standard](#)*
  - Note: Should be using a retractable. The
  - 6 lanyard and choker not working.
  - Severity Rating: Critical
  - Contributing Factor: Training
  - Responsible Party: E.J. Erectors
- *When performing roofing activities, the control line shall be erected not less than 6 feet nor more than 25 feet from all unprotected or leading edges of roof surfaces [reference 1926.502(g)(1)(i)]. [View OSHA Standard](#)*
  - Responsible Party: Atta Boy Roofing
