Re: Construction Safety Survey
Omaha, NE

Report Summary

Report Name: Construction Safety Survey
 Completed for: Best Company
 Inspection Date: July 23, 2018
 Location: Omaha, NE
 Contact: Bill Smith, Superintendent
 Job Number: 12345
 Project Manager: Tim Miller
 Region: Midwest
 Score: 61.4%

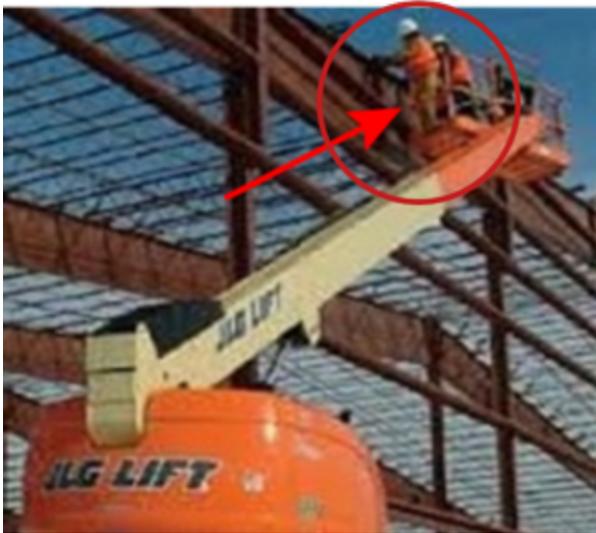
Observed one of the ironworkers standing on midrail when I arrived.

- *When working from an aerial lift, employees must stand firmly on the floor of the basket and not be allowed to step or climb on toeboard or railing of basket or use planks, ladders or other devices for a work position. Take appropriate steps to maintain compliance with this requirement. [reference 1926.453(b)(2)(iv)] [View OSHA Standard](#)*
 - Note: Worker observed standing on mid-rail of JLG
 - Responsible Party: E.J. Erectors

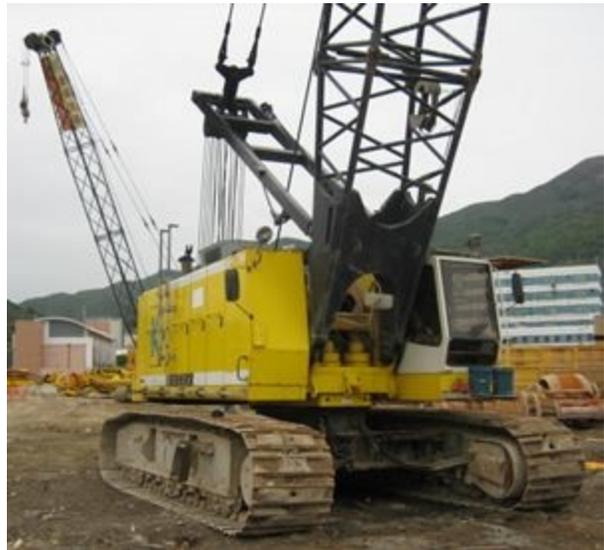
Radius guard is missing

- *All accessible areas within the swing radius of a crane shall be barricaded to prevent workers from being struck or crushed. Take appropriate action to address issues of non-compliance. [reference 1926.1424(a)] [View OSHA Standard](#)*
 - Note: Observed 3 crawler cranes on site and two of them did not have guards.
 - Severity Rating: Advisory
 - Responsible Party: Master Construction

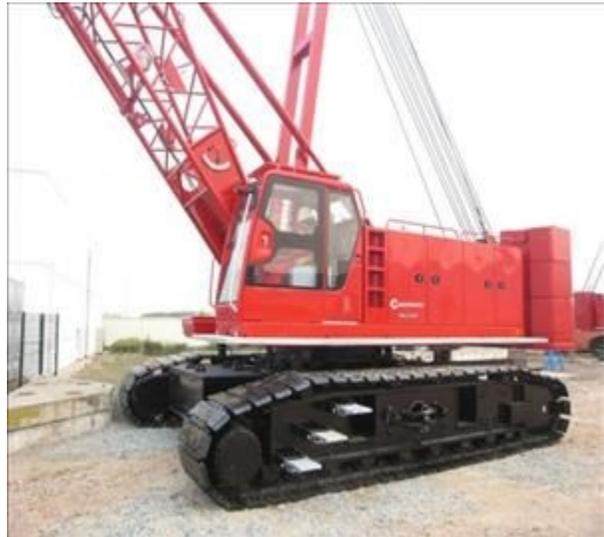
Radius guard is missing on this crane

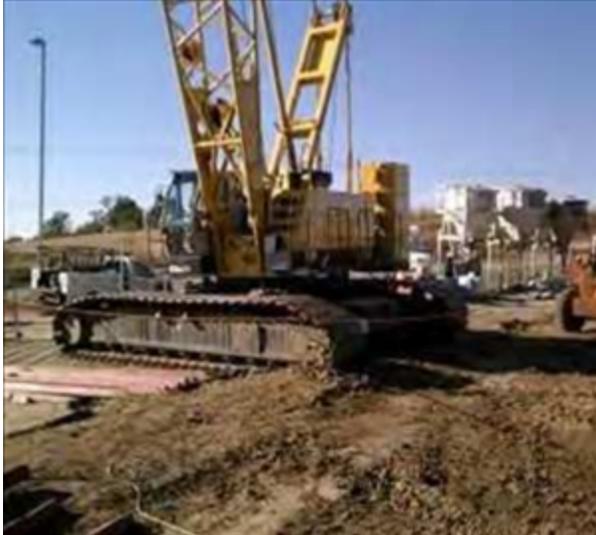
This crane has radius guard, but it should be flagged

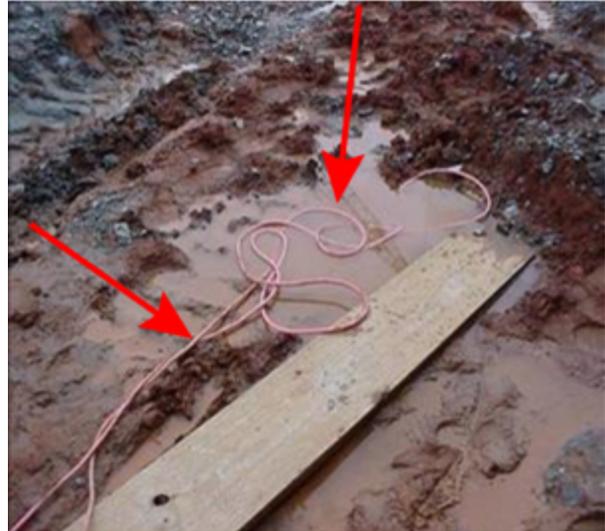
Flexible cord near job trailer should be relocated

- *Instruct workers to keep electrical cords reasonably clear of working spaces, walkways or similar areas to minimize trip/fall hazard and to protect cords from damage [reference 1926.416(b)(2)]. Consider re-routing cords away from active work areas or eliminating cords that are no longer needed. In some situations, it may be necessary to suspend cords (using an approved method) or bury them (using an approved protective cover) to minimize risk of damage or electrical shock. [View OSHA Standard](#)*
 - Note: Cord near job trailer needs to be relocated.
 - Responsible Party: Master Construction

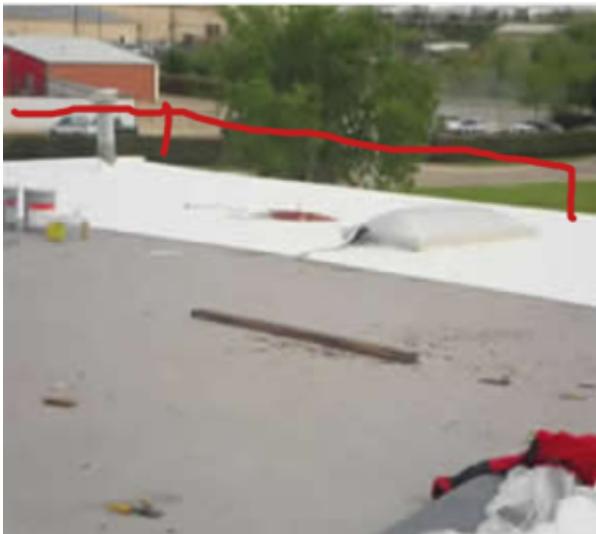
Need warning lines installed in area marked in red

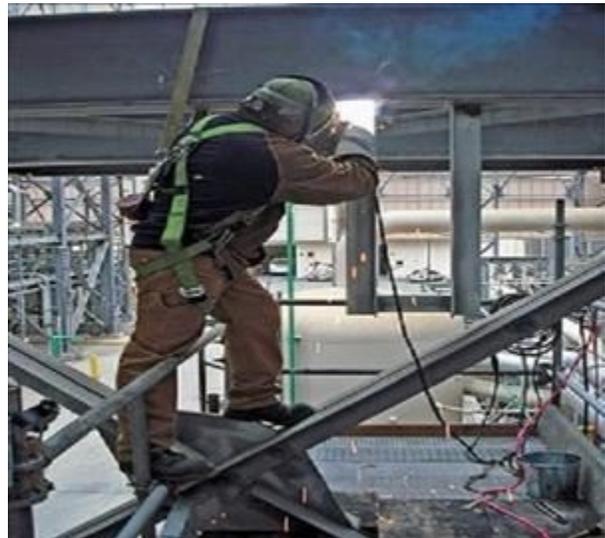
Consider alternative tie-off method (i.e. retractable to limit fall distance)

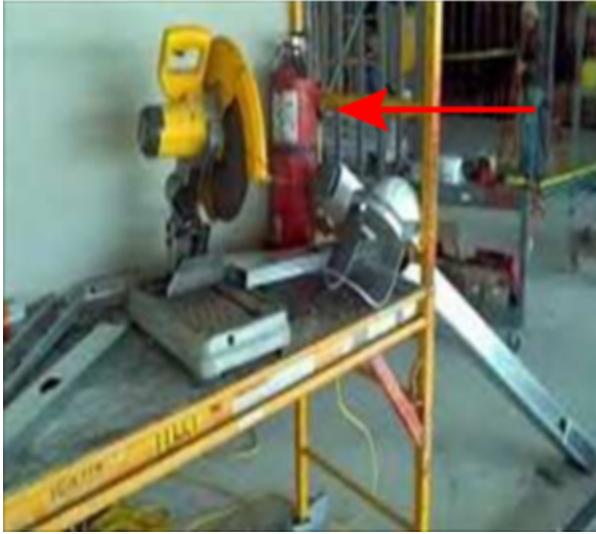
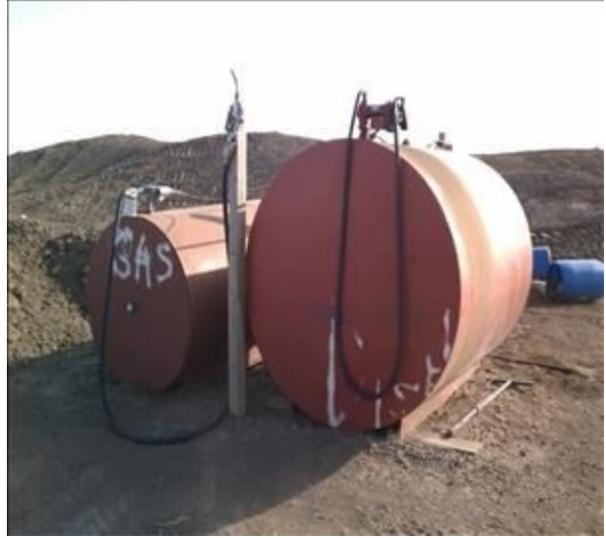
Fuel tanks are not properly labeled

- *Take steps to ensure fuel tanks are properly labeled and/or identified with fuel name stenciled on tank, flammable placards, etc. per requirements in NFPA 30 and/or applicable local/state codes.*
 - Note: Contact fuel supplier to have them label fuel tanks
 - Severity Rating: Advisory
 - Responsible Party: Panther Construction

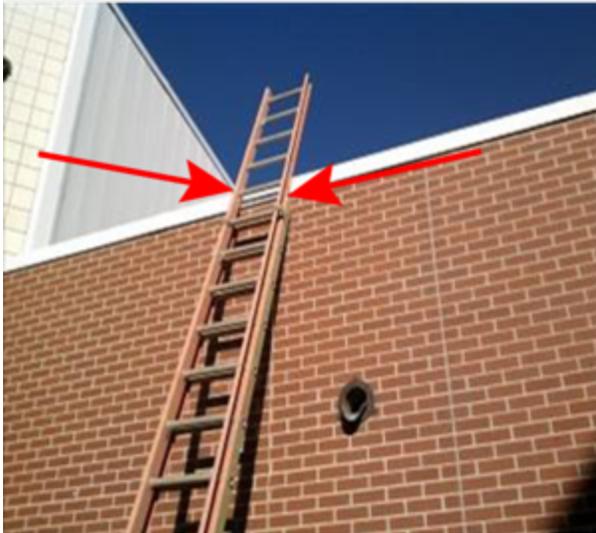
Ladder not secured

- Note: Ladder is sagging, doesn't appear to be set at proper angle
 - Responsible Party: E.J. Erectors
- *Take appropriate steps to ensure ladder side rails are secured to a rigid support to prevent the top of ladder from shifting (i.e. slipping sideways and possibly falling over). [reference 1926.1053(b)(1)] [View OSHA Standard](#)*

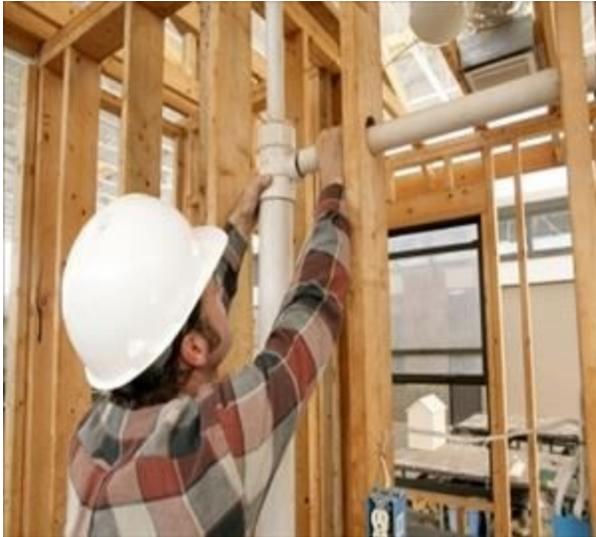
Contractor not wearing safety glasses

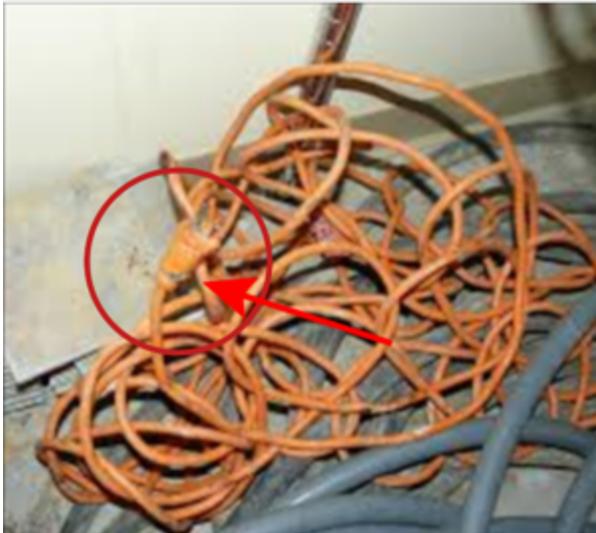
This cord was removed from service

- *Inspect electric cords or cables with each use and make sure worn or frayed cords are removed from service [reference 1926.416(e)(1)]. Ideally, damaged cords/cables should be completely removed from the work area and tagged DO NOT USE or they should be properly discarded (i.e. rendered unusable/cut in half, placed in trash receptacle). [View OSHA Standard](#)*
 - Note: Several cords were observed and most were in good condition, with the exception of the one pictured in this report. It was immediately removed from service.
 - Responsible Party: Best Contractor

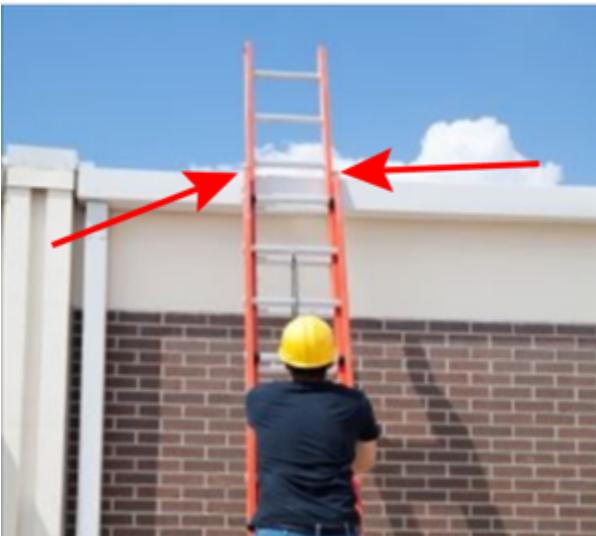
Ladder needs to be tied off
