SAFETY REPORTS

Re: Construction Safety Survey
Omaha, NE

Construction Report

Inspection Date: October 02, 2016
 Completed for: Best Company
 Report Name: Construction
 Location: Omaha, NE
 Contact: Bob Jones, Superintendent
 Project #: 12355
 Score: 70%
 Scope of Work: Safety Inspection

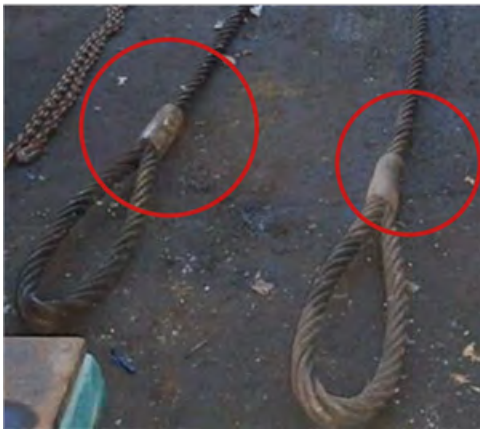
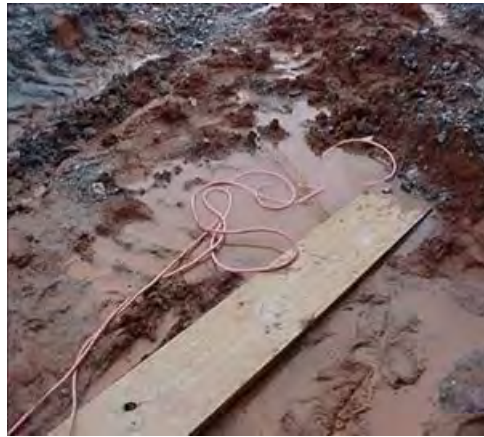
South end of project near Master storage trailer.

- *Take steps to maintain all work areas, frequently traveled pathways, entrances to and from the site, and other high travel areas reasonably level and free of slip, trip, fall hazards such as deep ruts, large rocks, steep slopes, etc. [Best Practice]*
 - Responsible Party: Master Construction

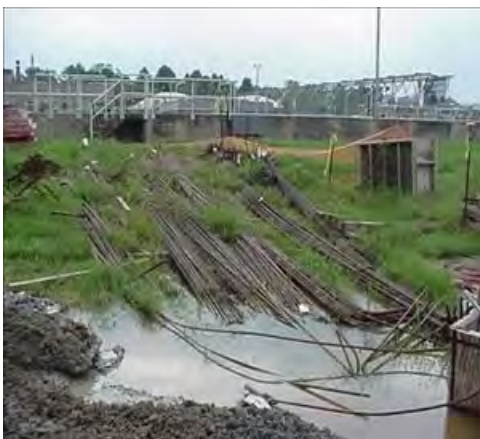
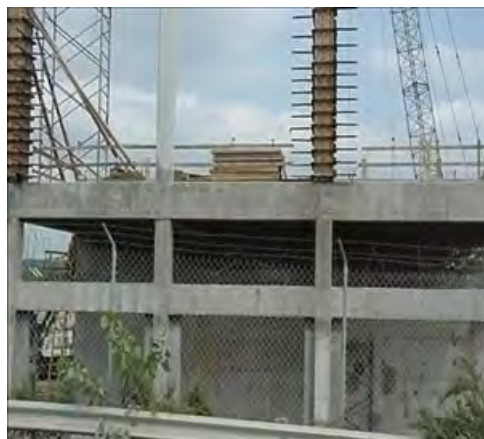
South end of project near Master storage trailer.

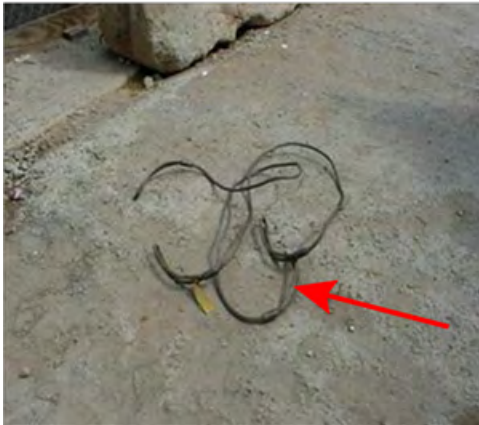
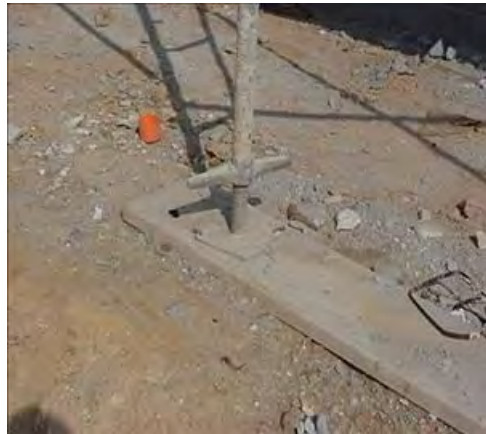
South end of project near Master storage trailer.

Specification tag missing

- *Employers must ensure that all rigging equipment (i.e. slings, fastenings, attachments, etc.) has permanently affixed and legible identification markings as prescribed by the manufacturer that indicate the recommended safe working load. Rigging equipment shall not be used if markings are missing or illegible. [reference 1926.251(a)(2)(i) and (iii)] [View OSHA Standard](#)*
 - Responsible Party: Best Contractor

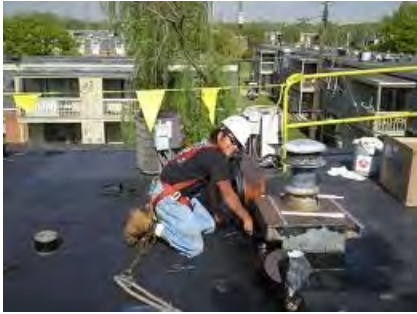
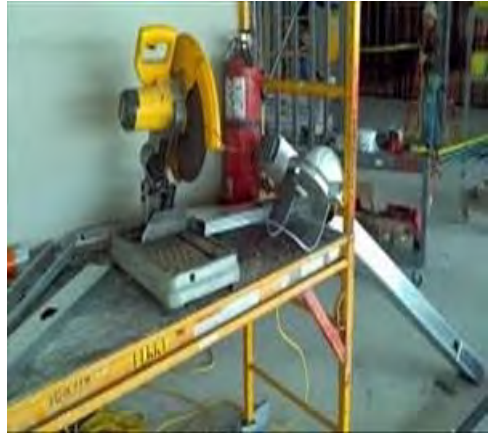
No warning line erected on north end of roof.
